**URGENT MEDICAL DEVICE CORRECTION****September 10, 2019****To:** Hospital/Surgeon Name**Affected Product:** ROSA Brain 3.0**Serial No.:** BRxxxxx

Medtech S.A - Zimmer Biomet - is initiating a medical device Field Safety Corrective Action for ROSA Brain 3.0 products. This notice informs you of the issue and the corrective actions Zimmer Biomet is taking.

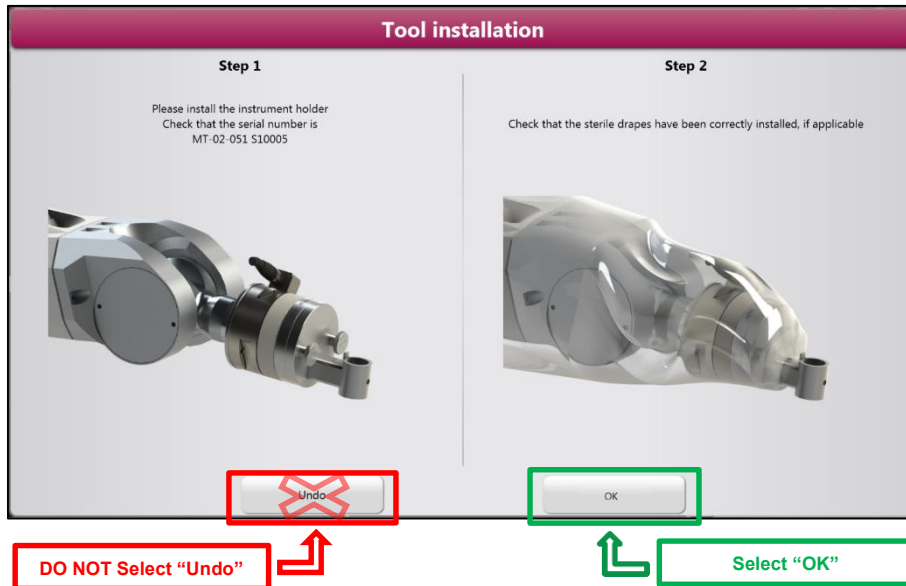
After the registration of the patient within the ROSA Brain 3.0 device, the issue may occur only in the guidance mode (e.g. when the robot arm is on trajectory), when the user selects the optical distance sensor and sends the robot arm on each entry point, and then selects the instrument holder. In such case, the use of the "Undo" button in the Tool installation panel will result in the issue due to a software anomaly.

- Once you select the instrument holder, if you would like to Undo your action :
  - DO NOT select "Undo"
  - Select "OK"

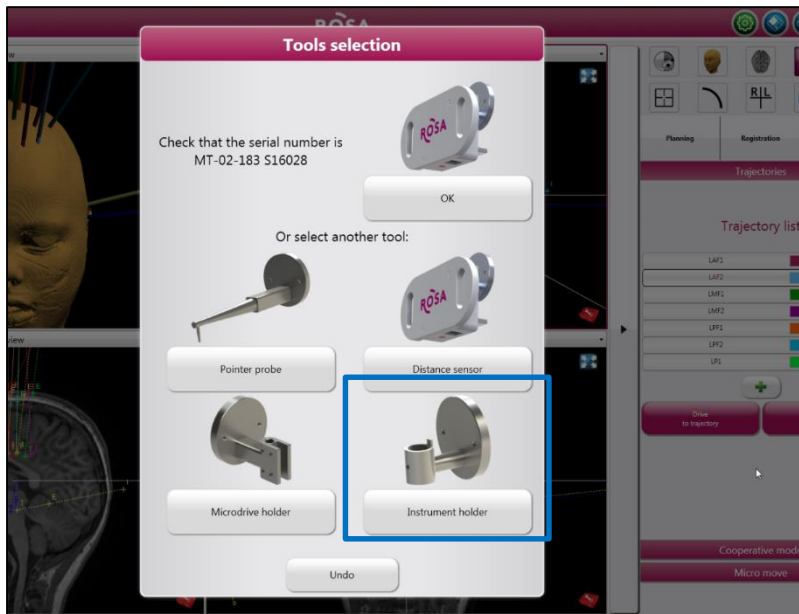
1. Use of the optical distance sensor during guidance mode, e.g. to mark entry points on the patient's head with a skin marker
2. Choosing drive to a trajectory and selection of the instrument holder

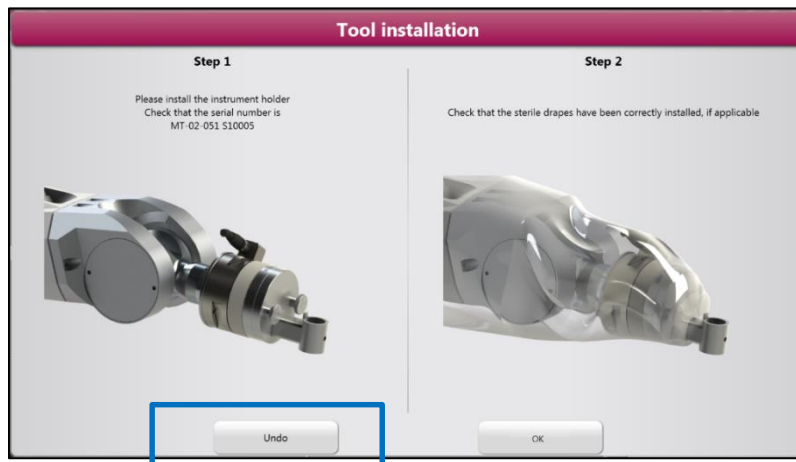
3. Installation of the instrument holder on the robot arm
4. Clicking undo on the tool installation frame

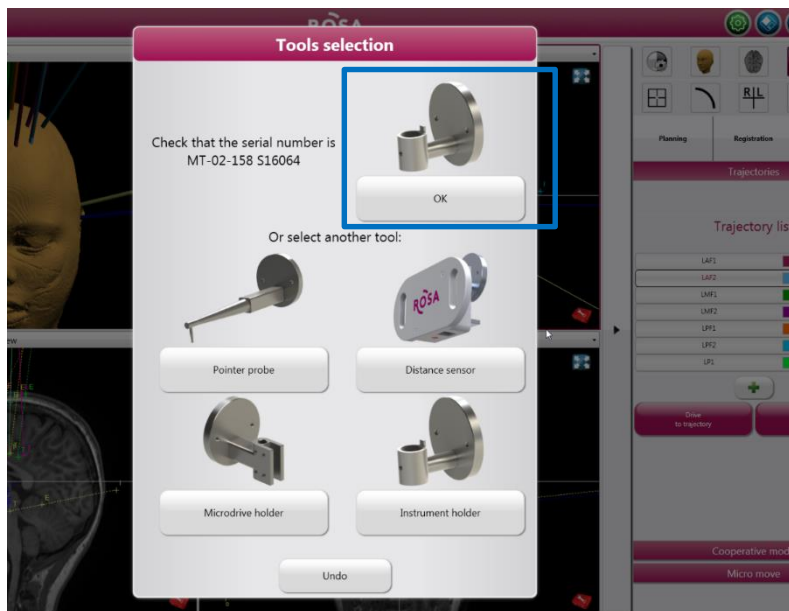
5. Choosing drive to a trajectory, then re-selection of the current instrument holder and drive to the trajectory

If the above listed steps are performed, the instrument holder may be sent on a trajectory that is not within the intended target.
