Zimmer® Trabecular Metal™ Total Ankle System Varus Deformities

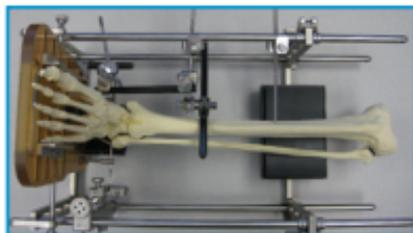
Carbon Fiber Rod.

To further stabilize the corrected alignment, a laminar spreader can be placed into the medial aspect of the joint until the tibial pins are inserted in the standard configuration 5cm and 20cm above the joint line, and the standard Carbon Fiber Rod is placed between the distal tibial pin and the lower medial longitudinal frame rod. This Carbon Fiber Rod should be placed more medially so it is closer to the frame, allowing an additional Carbon Fiber

Rod to be placed between the distal tibial pin and the talar neck pin to help maintain the alignment. This additional tibia-talus connection will add significant stability to the construct. Some surgeons may prefer to add this additional Carbon Fiber Rod in all cases, even those without any remaining deformity.

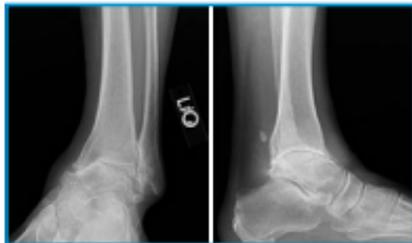
Anterior (left image) and Lateral (right image) x-ray of an ankle joint with a varus deformity.

This case involves a 68-year-old patient with a rotatory deformity and 20E of varus at the ankle, but minimal bone loss and no significant involvement of the subtalar joint. Osteophytes were visible on the lateral radiograph, and there was slight A/P translation. The surgeon preferred to avoid releasing the deltoid.

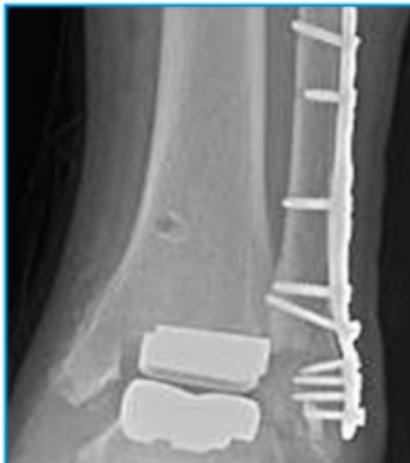
Anterior x-ray of the ankle joint replaced with the Zimmer Trabecular Metal Total ankle prosthesis.

Postoperative radiographs revealed that the tibia was still in approximately 5° of varus. At three days postoperatively, the patient returned to the OR for a supramalleolar tibial wedge osteotomy. This resulted in a neutral alignment, and reduced the likelihood of failure due to accelerated wear.

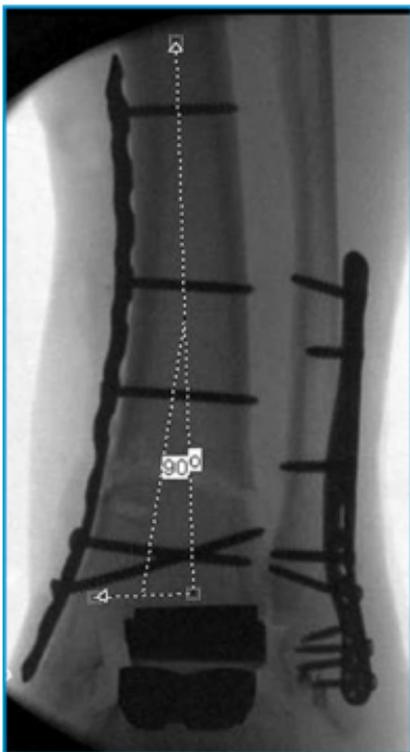
Anterior x-ray of the ankle joint replaced with the Zimmer Trabecular Metal Total Ankle prosthesis following a supramalleolar tibial wedge osteotomy.
