Persona® Tibial Articular Surface Provisional (TASP)

Disassembly Instructions

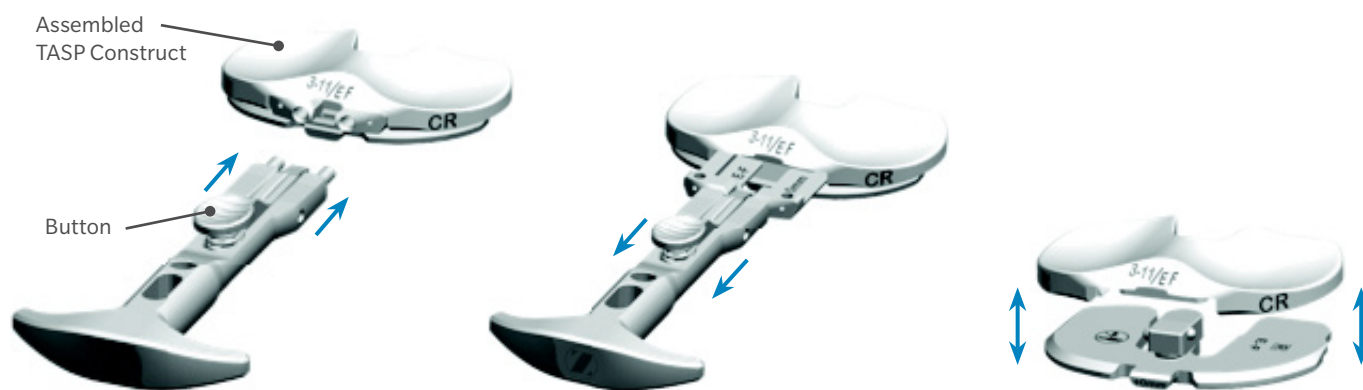
Disassembly Instructions

Step 1 – Insert Tibial Sizing Plate Handle (1) into Assembled TASP Construct by depressing button and inserting into Shim (2).

Step 2 – Remove the Shim (2) from the Top (3) and Bottom (4) by pulling the Tibial Sizing Plate Handle (1) away from the Assembled TASP Construct without depressing button. To avoid damage to the Top (3) and Bottom (4), do not impact or apply twisting forces to the Tibial Sizing Plate Handle (1) during shim removal.

Step 3 – Separate Top (3) from Bottom (4).

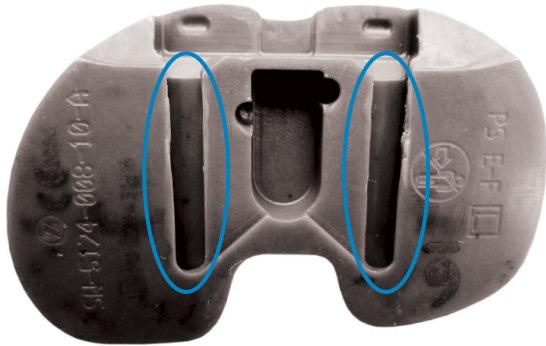
TASP Tops

Deformation along edges of dovetail

Due to multiple reuse cycles, damage of the TASP components resulting in mechanical failure is possible. Upon disassembly, evaluate components for damage and preliminary signs of failure. If damage is noticed, do not use the device and contact your Zimmer representative for a replacement. Below are preliminary signs of failure associated with the TASPs as seen in internal testing.

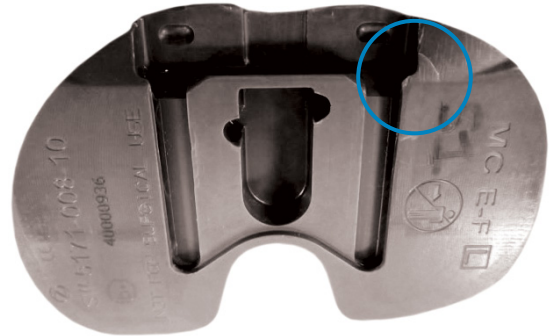
Cracks along length of dovetail

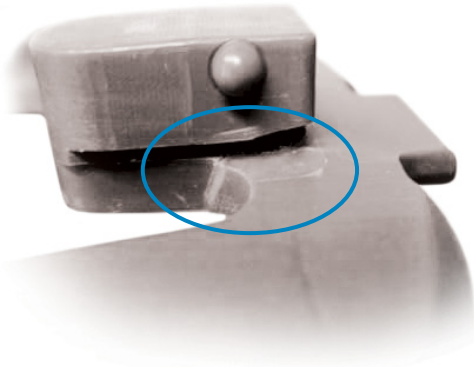
TASP Bottoms

Cracks/crazing along central post

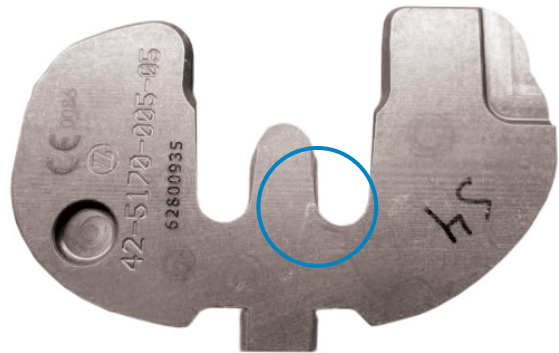
Cracks/crazing along central post
